**DEPARTMENT OF TRANSPORTATION**

Contract #: 04-0120F4Cty: SF/ALA Rte: 80 PM: 13.2/13.9File #: 69.28**WELDING INSPECTION REPORT****Resident Engineer:**Pursell, Gary**Address:** 333 Burma Road**City:** Oakland, CA 94607**Report No:** WIR-002700**Date Inspected:** 15-May-2008**Project Name:** SAS Superstructure**OSM Arrival Time:** 700**Prime Contractor:** American Bridge/Fluor Enterprises, a JV**OSM Departure Time:** 1500**Contractor:** Zhenhua Port Machinery Company, Ltd (ZPMC), Changxing Island **Location:** Shanghai, China**CWI Name:** C.M. Chen , Xu Jun**CWI Present:** Yes No**Inspected CWI report:** Yes No N/A**Rod Oven in Use:** Yes No N/A**Electrode to specification:** Yes No N/A**Weld Procedures Followed:** Yes No N/A**Qualified Welders:** Yes No N/A**Verified Joint Fit-up:** Yes No N/A**Approved Drawings:** Yes No N/A**Approved WPS:** Yes No N/A**Delayed / Cancelled:** Yes No N/A**Bridge No:** 34-0006**Component:** Side Plate, Bottom Plates, Deck Sections, Floor**Summary of Items Observed:**

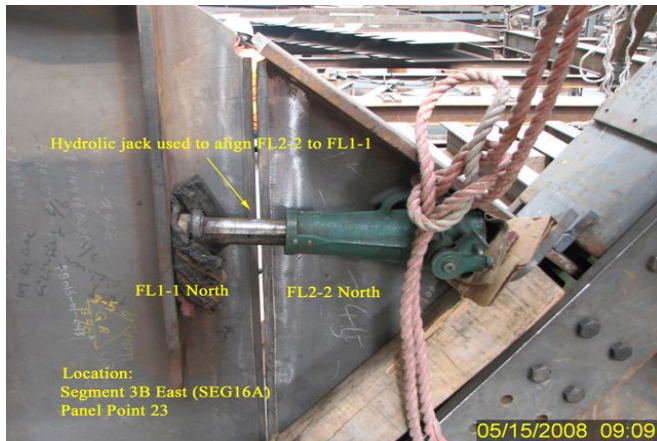
OBG Jig Fixture (South) Segment 3BE(SEG16A)/Panel Point 23:

Caltrans QA observed ZPMC personnel performing backgouging on the cross bracing connection plate Complete Joint Penetration (CJP) weld at the FL2-1 lower flange. The weld joint is identified as SSD19A-PP023-132. ZPMC personnel were also observed aligning the Floor Beams FL2-2 with FL1-1(North). In order to align the segments,ZPMC personnel are using a hydrolic jack positioned against segments FL2-2(North)and FL1-1(North). See attached photo.
